Manhole Inspection Summary

Manhole # S39U1_001MH

Insp Date: **5/6/08 1:32 PM**

Location Address: **428 5th St.**

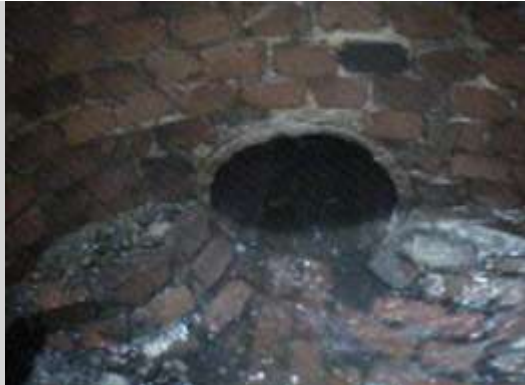
12 O'Clock Outflow

12 in. Circular Gravity Sewer
Pipe Out @ 12 O'Clock

Pipe Height: **12** (in.) Rod and Bar (Angled)
Pipe Material: **Clay** ☐ Pipe Lined
Invert Depth: **15.28** (ft.) Flow Characteristics: **Fast**
Deposits: ☒ None ☐ Mud ☐ Sludge ☐ Debris ☐ Grease
Silt Depth: (in.) Deposits Extent:
Infiltration: **None** Pipe Seal Cond: **Sound**

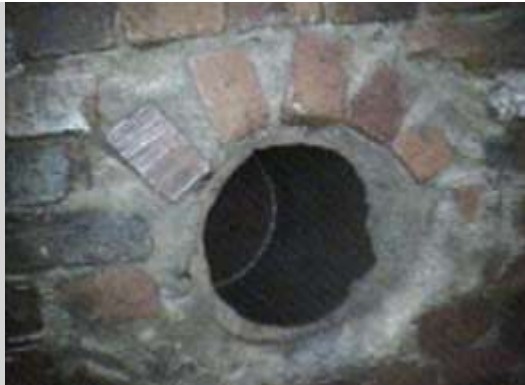
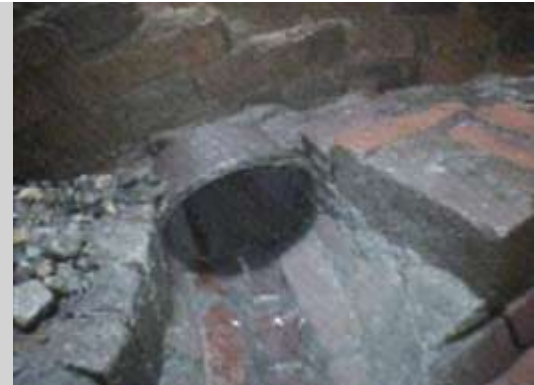
4 O'Clock Inflow

8 in. Circular Gravity Sewer

Pipe In @ 4 O'Clock

Drop In @ 4 O'Clock

Pipe Height: **9.6** (in.) Rod and Bar (Angled)

Drop: **Outside** Rod and Bar
Angled: **Yes** Reading: **13.82** (ft.)
Inv Depth: **14.82** (ft.)
Drop Condition: **Open**

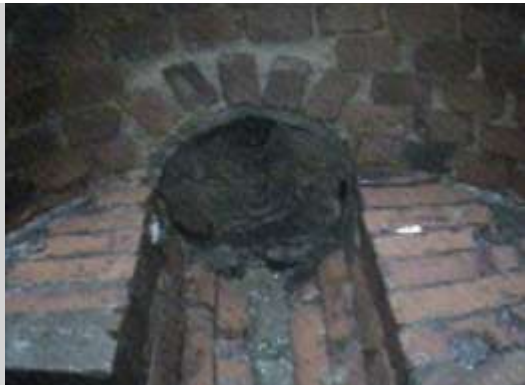
6 O'Clock Inflow

12 in. Circular Gravity Sewer

Pipe In @ 6 O'Clock

Pipe Height: **3.6** (in.) Rod and Bar (Angled)
